VEHICLE INSPECTION REPORT

WN69YNA

Mercedes-Benz Sprinter 314 CDI

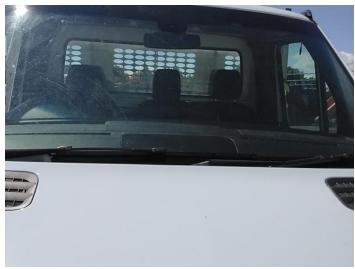
1: Screen Front Chipped Over 10mm

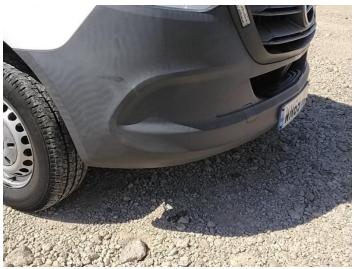
2: Bumper Front Moulding Scuffed (Unpainted) UpTo 100mm

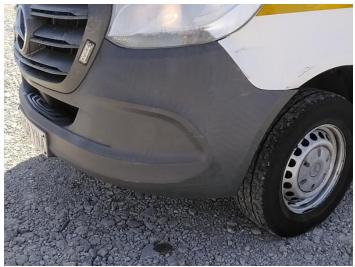
3: Bumper Front Moulding Scuffed (Unpainted) UpTo 100mm

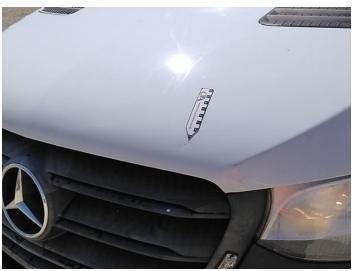
4: Bonnet Dented 2 Or Less UpTo 10mm

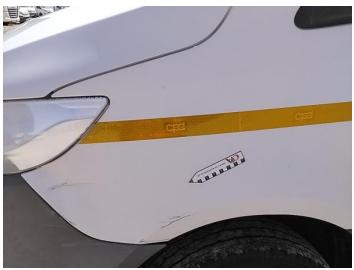
5: Wing nsf Dented With Paint Damage

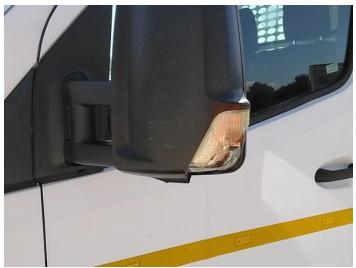
6: Door Mirror Assy nsf Scuffed (Unpainted) UpTo 100mm

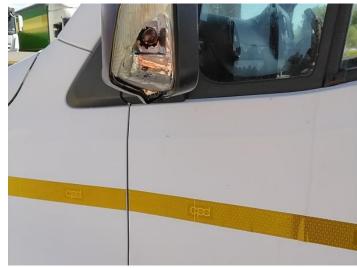
7: Flasher Side Repeater ns Broken Replace

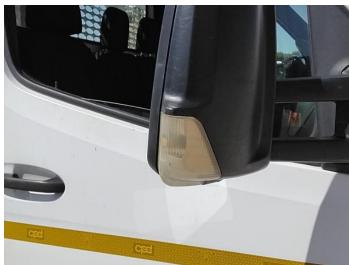
10: Door Mirror Assy osf Scuffed (Unpainted) UpTo 100mm

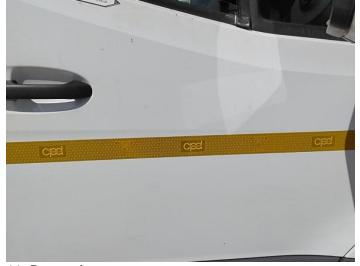
11: Door osf Chipped 1 To 5
